REPORT OF INVESTIGATION

Underground Nonmetal Mine  
(Limestone)

Fatal Machinery Accident  
March 24, 2003

JS&G Underground Mine #1  
Joliet Sand & Gravel Company  
Joliet, Will County, Illinois  
Mine I.D. No. 11-03084

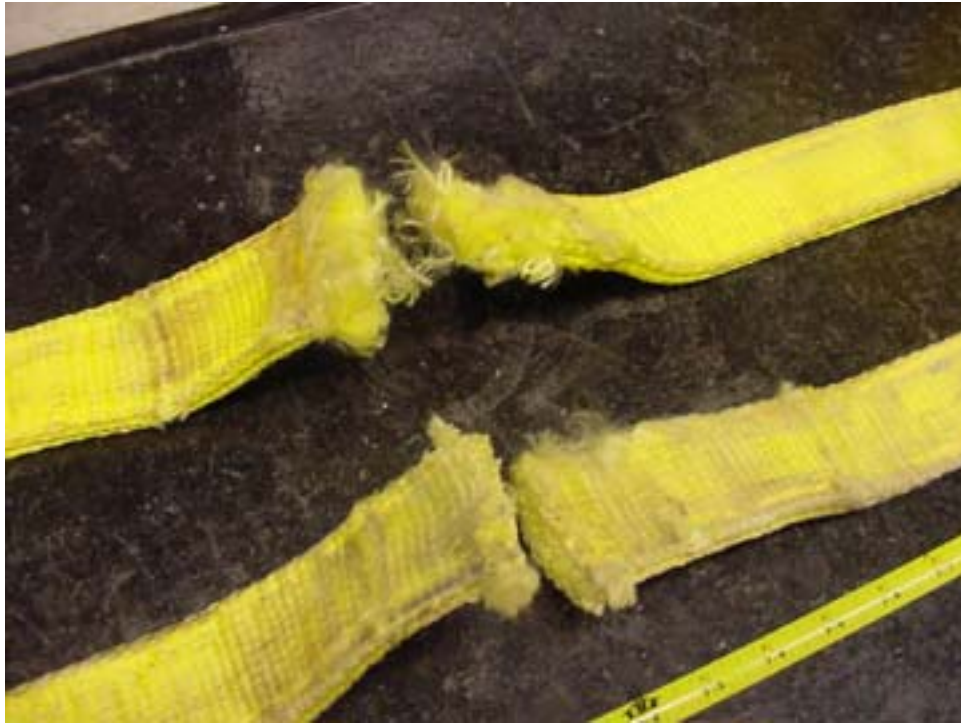
## Appendix C

The two failed nylon straps were taken from the scene by the Will County Sheriff's Department. The custody of the slings was then transferred to MSHA for further evaluation on April 2, 2003. (See photograph of slings in Appendix C.)

One nylon sling was used to suspend the east side of the plates and the other strap was used to hold up the west side. The two pieces of the east side sling were referred to as the north and south pieces, respectively. The north piece was 70 inches long from the end of the eye loop to the break location. The break would have corresponded with the lower north corner of the basket configuration. The south piece was 75 inches long from the end of the eye loop to the break location. Approximately 32 inches from the eye loop of the south piece, there was a distinct abrasion area on the sling that appeared to be partly cut. This would have corresponded to the south corner of the basket configuration. Likewise, evidence of yellow abraded nylon sling fibers was found adhering to the lower south edge of the east side of the stack of plates.

The two pieces of the west side sling were also referred to as the north and south pieces, respectively. The north piece was 63-1/4 inches long from the end of the eye loop to the break location. The break corresponded with the contact location of the lower north corner of the basket configuration. The south piece was 82-1/2 inches long from the end of the eye loop to the break location. Approximately 40-1/2 inches from the eye loop on the south piece, there was a distinct abrasion area on the sling where it had started to be cut. This would have corresponded to the south corner of the basket configuration.

On April 23, 2003, an identical sling from the same manufacturer was tested at Safety Sling in Pittsburgh, Pennsylvania. The tension load to break the sling was nearly 32,000 pounds. This was at the expected factor of safety for a sling of this width. A direct pull test showed that a failure from tension overload is clearly different than the type of relatively abrupt tears that occurred when the slings were used around unprotected sharp plate corners on the day of the accident. The failure surface of the tested sling had no distinct edge and had considerably more fraying than the accident slings.

Corrective Action - Always refer to manufacturer's recommendations, hazard alerts and warnings. The nylon straps had labels stamped with warning to protect straps from sharp edges and rough loads.
